Lessons Learned:

Western Beltway

Post Construction Review

November 14, 2008

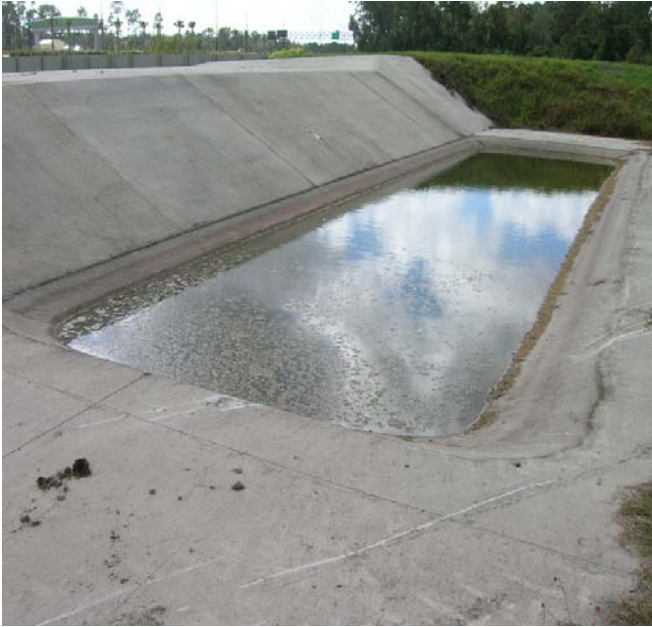
Drainage Outfall at Mainline Barrier Plaza

Issue: Drainage outfall retains approximately 18" of water. The stagnant water can breed mosquitoes and is aesthetically unsightly.

Lessons Learned: The outfall is designed as a "spreader swale". The spreader swale should be designed as a sodded berm, if conditions will allow it. If a concrete structure is required, then the basin sump elevation should be located above the seasonal high water (SHW) table elevation. The EOR should check to make sure the bottom of the spreader swale can remain dry during both the wet and dry seasons.
